Manhole Inspection Summary

Manhole # S13EE_011MH

Location Address: **REAR OF 1412 POPLAR GROVE ST** Cross Street: **BELMONT AVE**

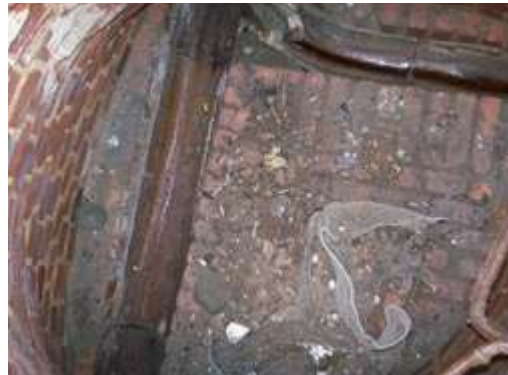
Top View

DEBRIS

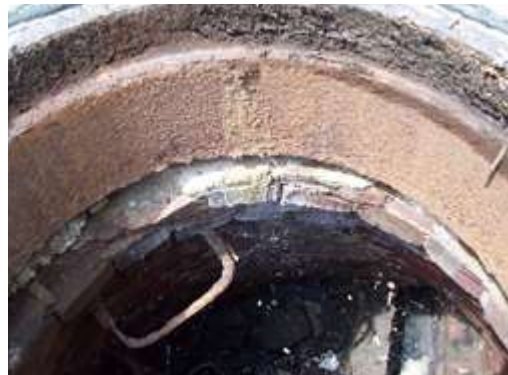
Defect 3

Steps Count: **2** Missing: **0** ☒ **Corroded**

CORRODED STEPS

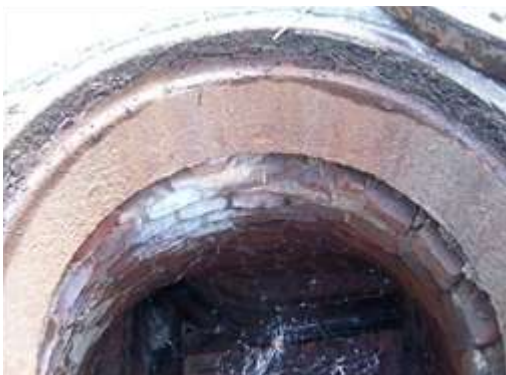
Defect 1

Chimney / Frame Adjustment ☒ Exists Material: **Brick and Concrete** ☐ Parged Height: **4** (in.)

Condition: ☐ Sound ☒ **Cracked** ☐ Root Intrusion ☐ Loose Brick ☐ Deteriorated

CRACKED CHIMNEY

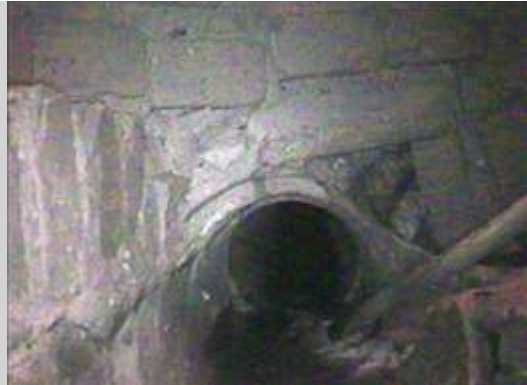
12 O'Clock Outflow

8 in. Circular Gravity Sewer
Pipe Out @ 12 O'Clock

Pipe Height: (in.) Direct
Pipe Material: **Clay** ☐ Pipe Lined
Invert Depth: **5.90** (ft.) Flow Characteristics: **Slow**
Deposits: ☒ None ☐ Mud ☐ Sludge ☐ Debris ☐ Grease
Silt Depth: (in.) Deposits Extent:
Infiltration: **None** Pipe Seal Cond: **Sound**

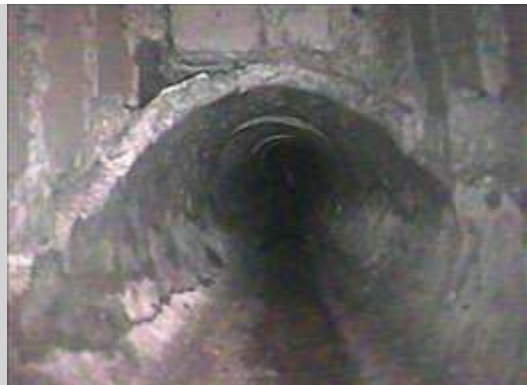
3 O'Clock Inflow

6 in. Circular Gravity Sewer
Pipe In @ 3 O'Clock

Pipe Height: (in.) Direct
Pipe Material: **Clay** ☐ Pipe Lined
Invert Depth: **5.55** (ft.) Flow Characteristics: **Slow**
Deposits: ☒ None ☐ Mud ☐ Sludge ☐ Debris ☐ Grease
Silt Depth: (in.) Deposits Extent:
Infiltration: **None** Pipe Seal Cond: **Sound**

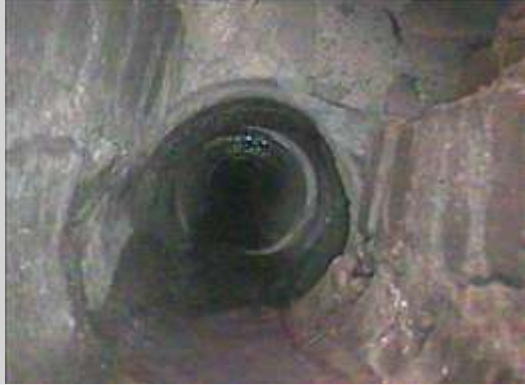
6 O'Clock Inflow

8 in. Circular Gravity Sewer

Pipe In @ 6 O'Clock

Infiltration: **None** Pipe Seal Cond: **Sound**
